# Gaddy Home Inspection

Page 1 of 17  
26 August 2009-BJourdan

Property Address 6337 New Pines Drive

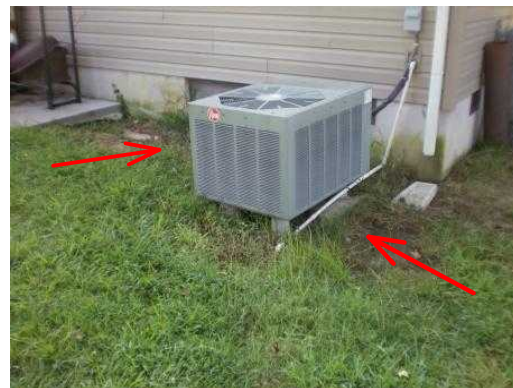
| 8. | <input type="checkbox"/> | <input type="checkbox"/> | <input type="checkbox"/> | <input checked="" type="checkbox"/> | <input type="checkbox"/> | Grading: Negative slope against foundation.<br>Moisture directed towards crawlspace<br>access. Moisture pooling around AC unit. |

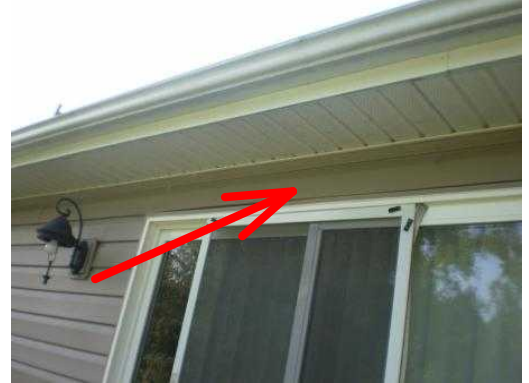
1.      Type: Vinyl siding Siding loose above rear patio door.

Marginal: Several small areas of damage or holes in rear and right end siding

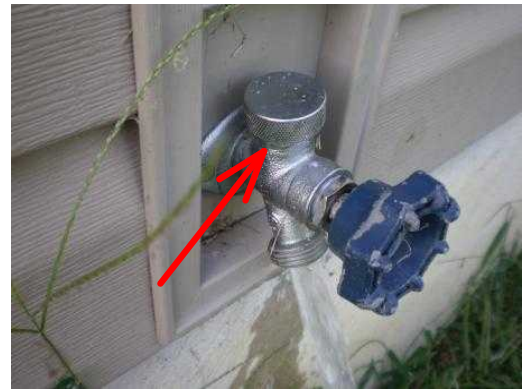
2.      Trim: Aluminum, vinyl, and wood  
3.      Fascia: Aluminum and wood  
4.      Soffits: Vinyl  
5.      Door Bell: Hard wired  
6.      Entry Doors: Metal and wood  
7.      Patio Door: Vinyl sliding Screen frame bent on patio door  
8.      Windows: Vinyl single hung  
9.      Storm Windows:  
10.      Window Screens: Screen frame bent in front left window; Screen missing in kitchen window;  
11.      Basement Windows:  
12.      Exterior Lighting: Globe missing on rear porch light  
13.      Exterior Electric Outlets:  
14.      Hose Bibs: Vent leaking on rear faucet

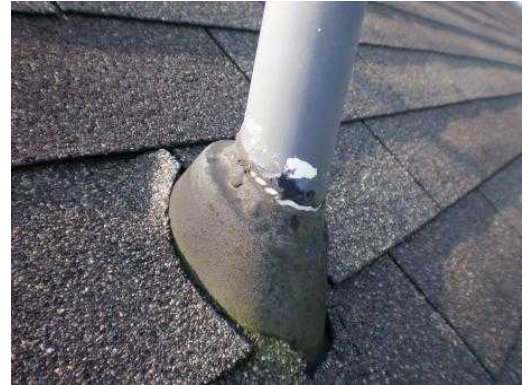
1. Method of Inspection: Ground level and ladder at eaves
2.  Unable to Inspect:
3.  Material: Asphalt shingle
4. Type: Gable
5. Approximate Age: 2003
6.  Flashing:
7.  Valleys:
8.  Skylights:
9.  Plumbing Vents: PVC Monitor collars on plumbing vent flashings for splitting

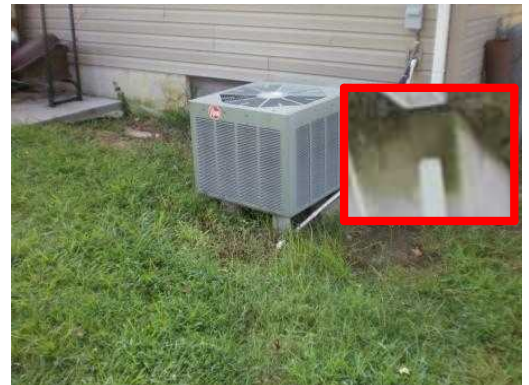
10.  Electrical Mast:
11.  Gutters: Aluminum
12.  Downspouts: Aluminum Shoe missing on rear left downspout

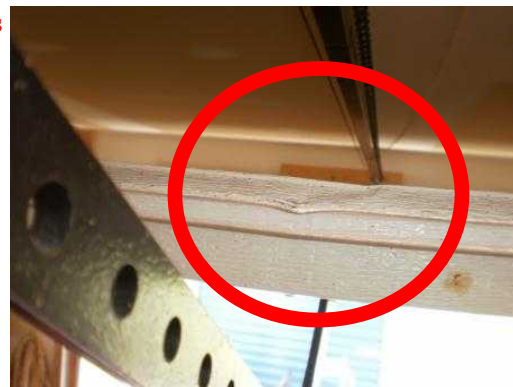
1. Type of Structure: Attached Car Spaces: 1
2.      Garage Doors: Insulated aluminum Top panel is bent and cracked on garage door.

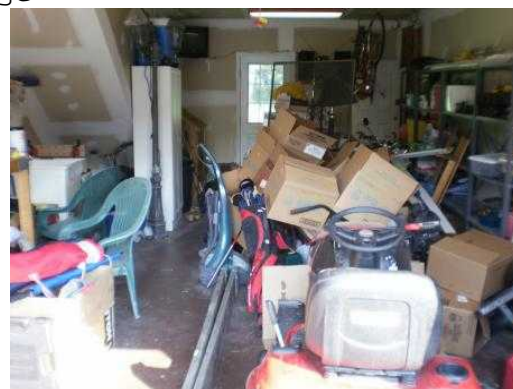
3.      Door Operation: Mechanized
4.      Door Opener: Craftsman Reecommend adjusting height of safety sensors
5.      Exterior Surface: Vinyl siding
6.      Roof: Asphalt shingle
7.      Service Doors: Metal and wood
8.      Ceiling: Sheetrock
9.      Walls: Sheetrock Limited access due to storage
10.      Floor/Foundation: Poured slab Limited access due to storage

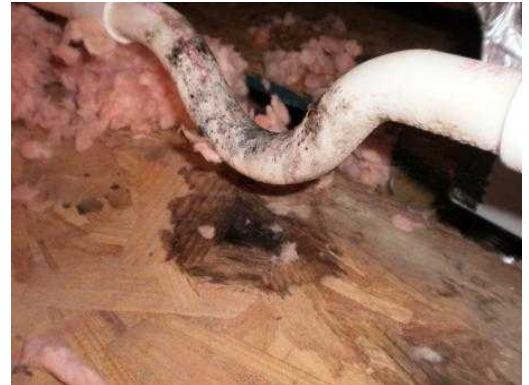
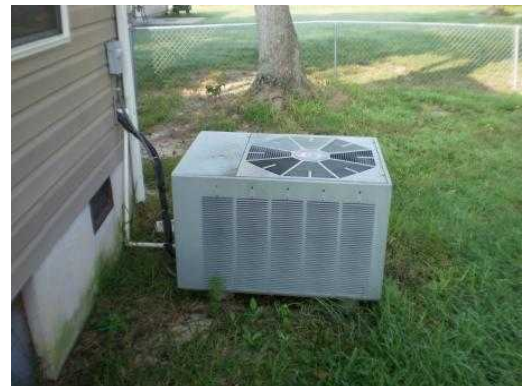
1.  A/C System Operation: Appears serviceable
2.  Condensate Removal: PVC Insulation omitted on condensate drain trap in attic. Dripping on plywood noted.
3.  Exterior Unit: Pad mounted Unit not level

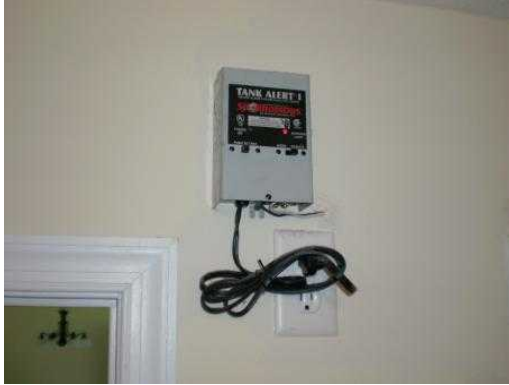
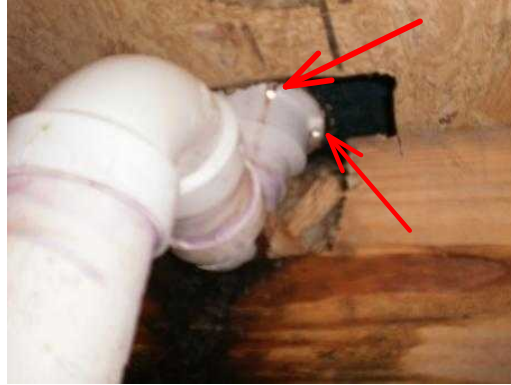
Drain Pipes: **Septic alarm is set on silent but sounds continuously when set on horn.**

**Leaking at master bathroom shower drain into crawlspace ... framing wet. Further evaluation required by a qualified contractor.**

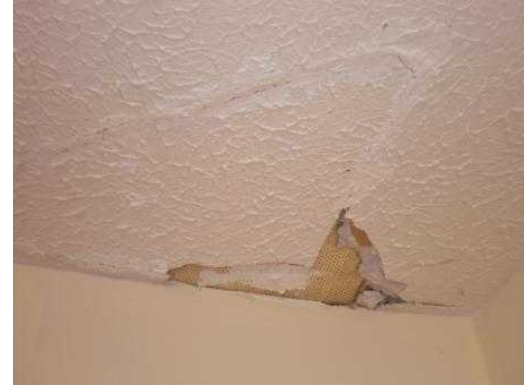
1.      Closet: Walk In  
2.      Ceiling: Sheetrock Ceiling damaged in rear right corner. Hole open to ceiling.

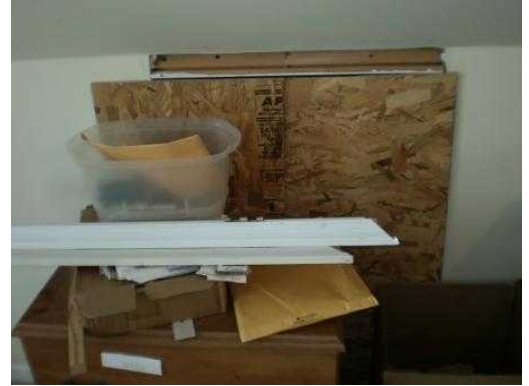
1.      Closet:  
2.      Ceiling: Sheetrock  
3.      Walls: Sheetrock Sheetrock cut away on front wall to access kneewall space, door and frame missing, temporary door on access.

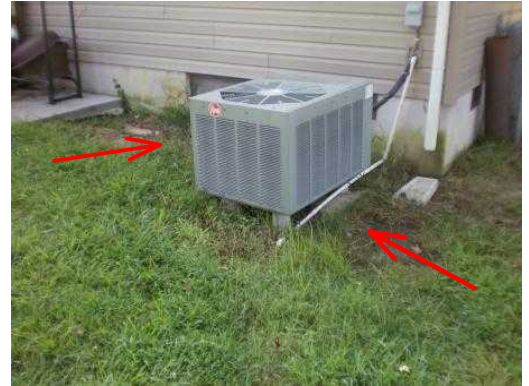
1. **Steps/Stoops:** Brick Missing handrails;  
Center column removed on front porch
2. **Grading:** Negative slope against foundation. Moisture directed towards crawlspace access. Moisture pooling around AC unit.

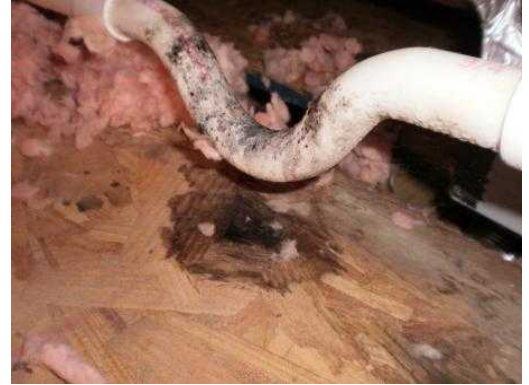
11. Rear of house AC System Condensate Removal: PVC Insulation omitted on condensate drain trap in attic. Dripping on plywood noted.

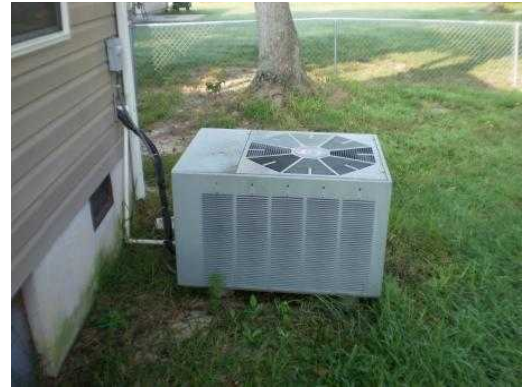
12. Rear of house AC System Exterior Unit: Pad mounted Unit not level

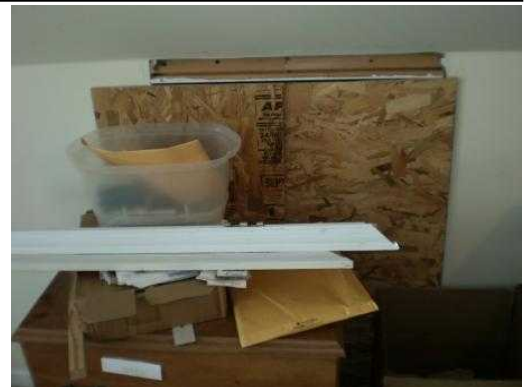
17. Bonus Room Living Space Walls: Sheetrock Sheetrock cut away on front wall to access kneewall space, door and frame missing, temporary door on access.

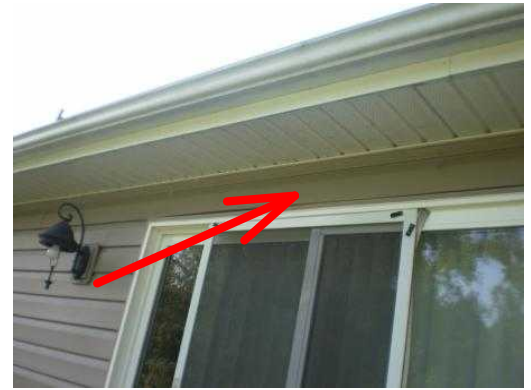
1. Main covering Exterior Surface Type: Vinyl siding **Siding loose above rear patio door.**

**Marginal: Several small areas of damage or holes in rear and right end siding**

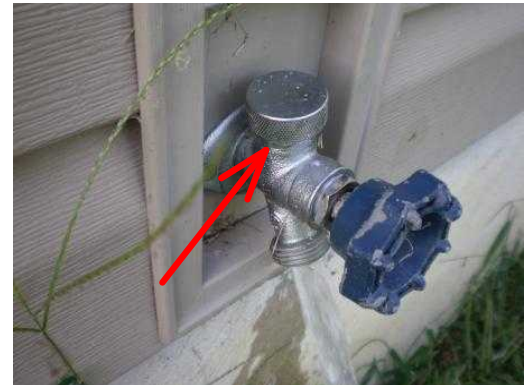
2. Hose Bibs: **Vent leaking on rear faucet**

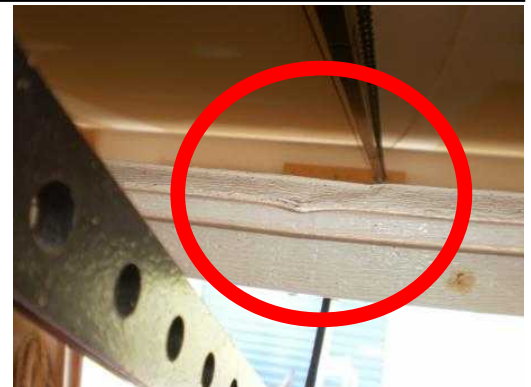
3. Front Garage Garage Doors: Insulated aluminum **Top panel is bent and cracked on garage door.**

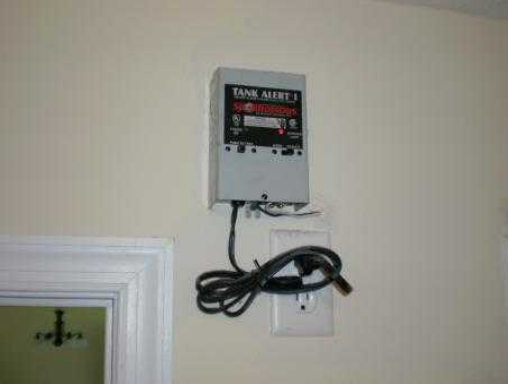
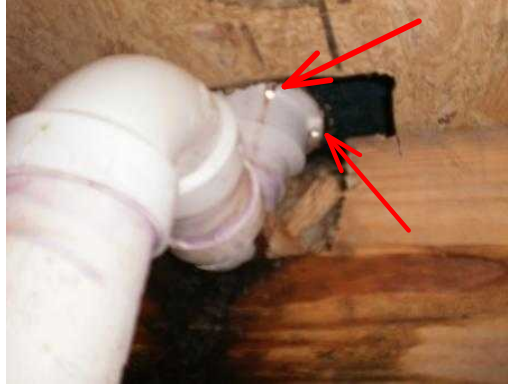
5. Drain Pipes: **Septic alarm is set on silent but sounds continuously when set on horn. Leaking at master bathroom shower drain into crawlspace ... framing wet. Further evaluation required by a qualified contractor.**

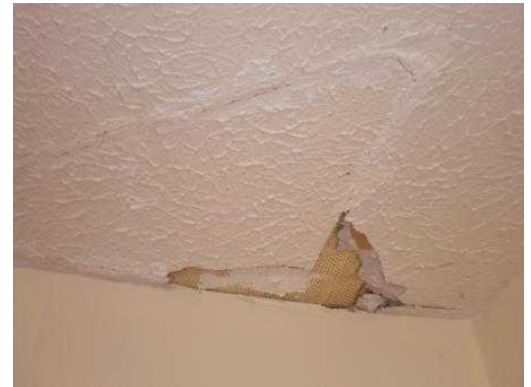
10. 1st Floor Master Bedroom Ceiling: Sheetrock Ceiling damaged in rear right corner. Hole open to ceiling.
